Somerset Rivers Authority (SRA) Board Paper

River Sowy - King's Sedgemoor Drain (KSD) Enhancements Scheme: KSD banks and outfalls

To update the SRA Board on progress with the final stage of the River Sowy – King's Sedgemoor Drain (KSD) Enhancements Scheme Phase 1 work.

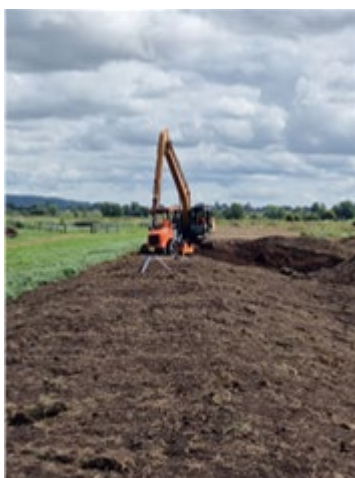
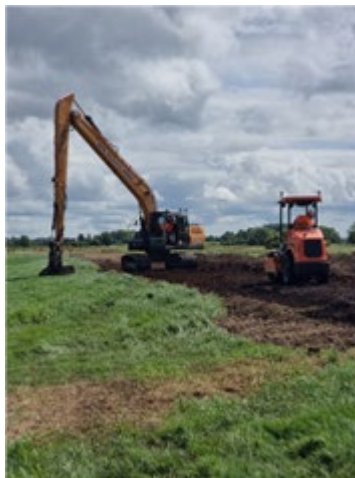
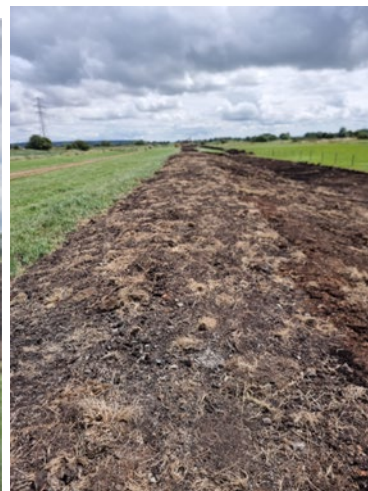
A site compound was set up in the first week along with removal of existing temporary fencing and erection of temporary fencing. A number of trial holes were excavated to undertake soil analysis of the existing bank material at intervals along the length of the works. The results of the soil testing were positive and bank raising works were able to commence in earnest on 7 July 2025 starting at Chedzoy Sluice and moving to the southeast to link up with the bank raised by the Environment Agency in 2022.

Works are now progressing to the north of Chedzoy Sluice towards Parchey with a view to completing the works before the end of September, as per the programme.

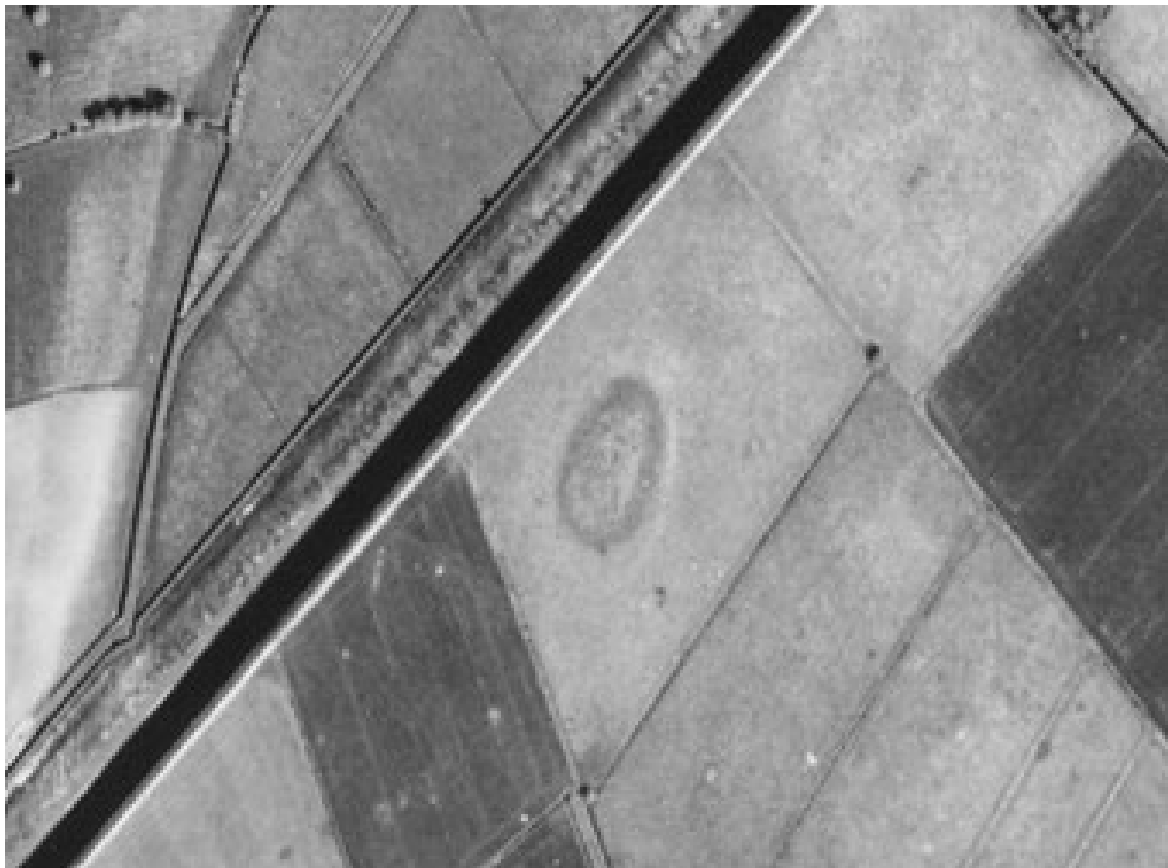
1. The pre-commencement survey and initial setting out for the works measured the length of the works to be 1960m which is longer than the 1.8km indicated within the Environment Agency specification and so the length of works has increased by 160m.
2. There is a short stretch of about 100m where the existing flood bank intersects a feature know as 'the mound' (aerial photo from 1942 below). In consultation with South West Heritage Trust, we were informed that this feature is a potential Anglo-Saxon burial ground where a dugout canoe was found in the late 1950s.

In order to avoid any impacts on the historical 'mound' we adjusted the works to avoid disturbing the ground in the vicinity of this feature.

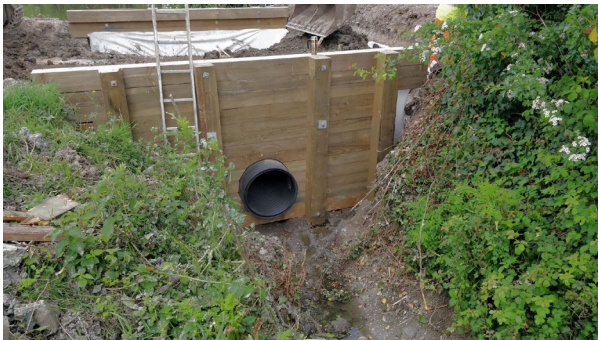
Upstream head wall

Contractors commenced on site at Back Ditch on 28 April 2025, once ground conditions allowed. Works were completed on 12 May 2025 with the contractor moving straight across to Chedzoy Tilting Weir. The landowner was pleased with the completed project and was able to start using the gated access for his cattle immediately following completion.

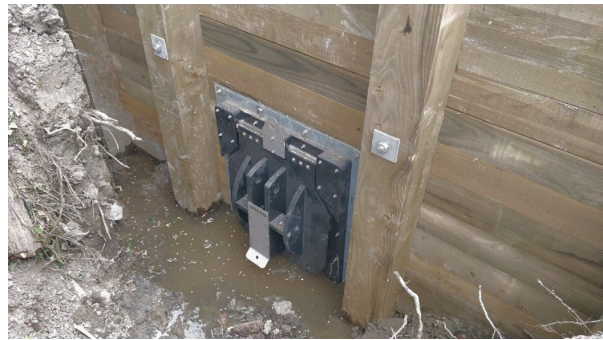
Downstream flap valve
